PROJECT: Midnite Mine Remediation

REPORT NO: 2019-008

Summary of Work Activities or Events for this reporting period:

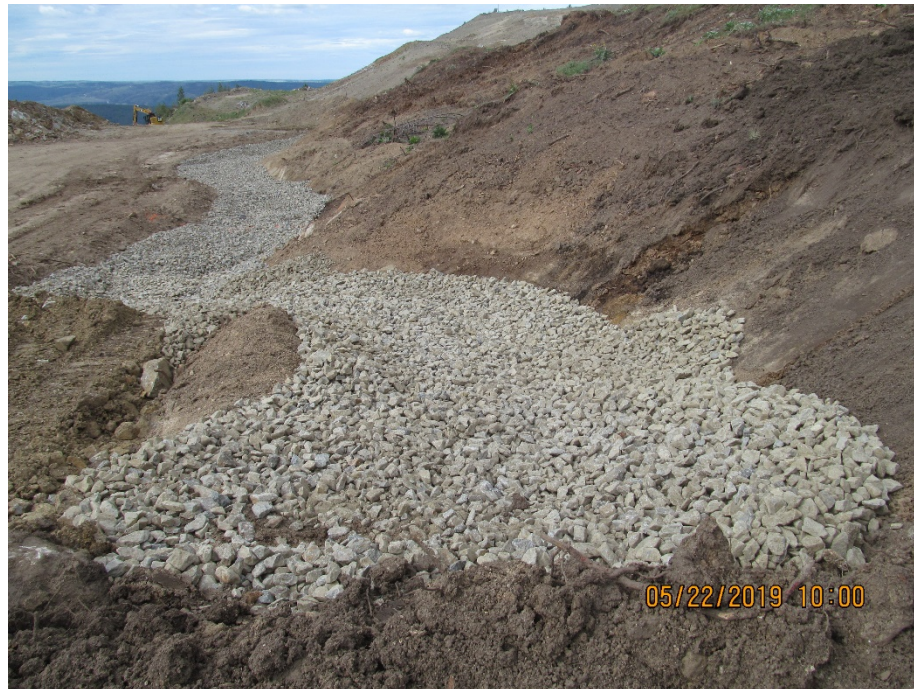
Figure 1 West Infiltration Collector (WIC), Mini-Collector Constructed Adjacent to the West Side of the Main Collector Located between the First and Second Laterals, Looking South

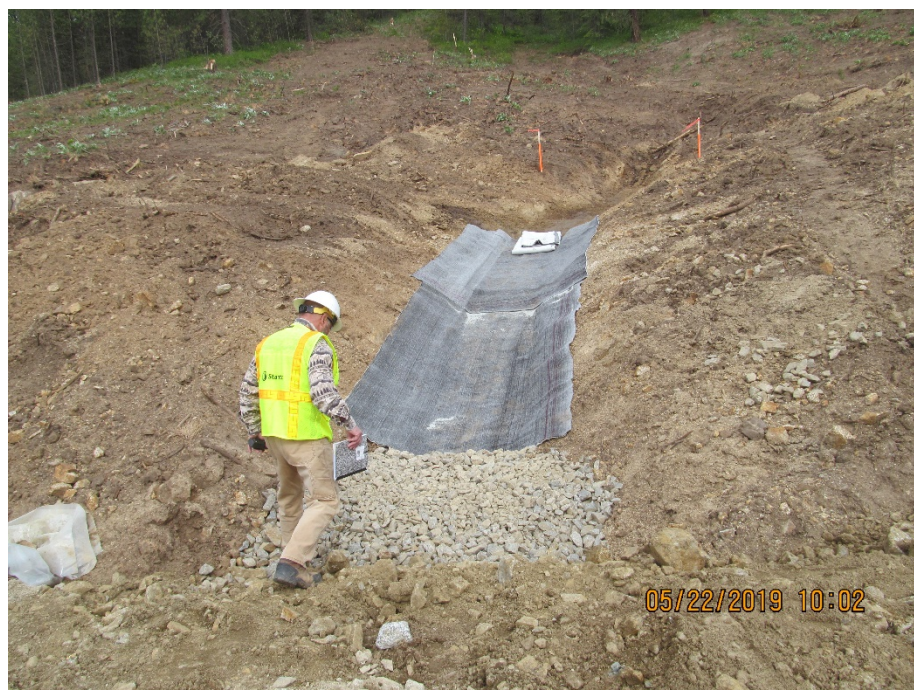
**Figure 2 First Lateral Located Along the West Side of the WIC Main Collector
CQC Inspecting GCL Placement, Looking West**

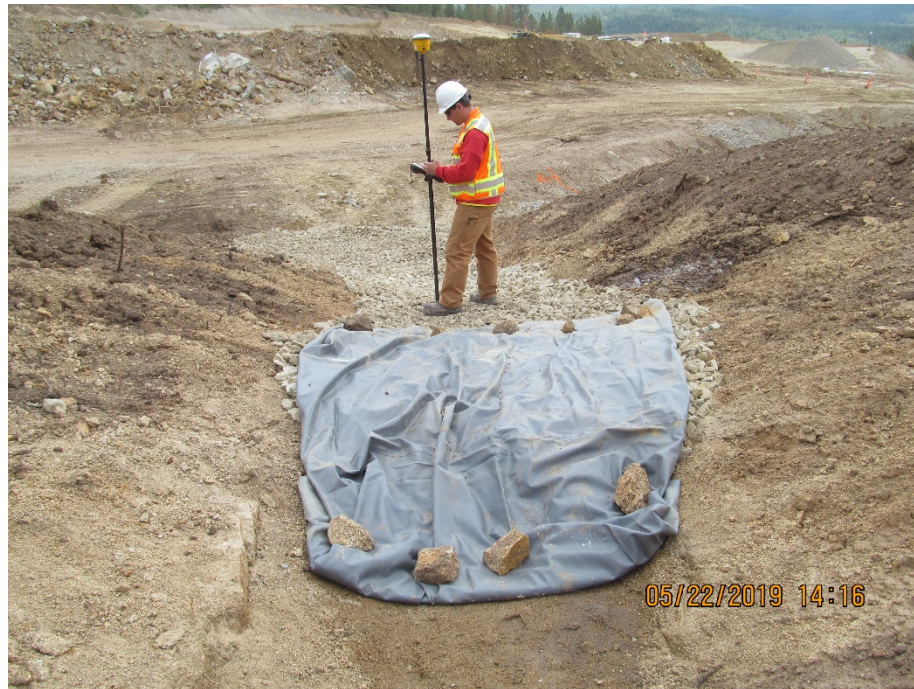
**Figure 3 First Lateral Located Along the West Side of the WIC Main Collector
CQC Surveying Top of Drain Gravel Placement, Looking East**

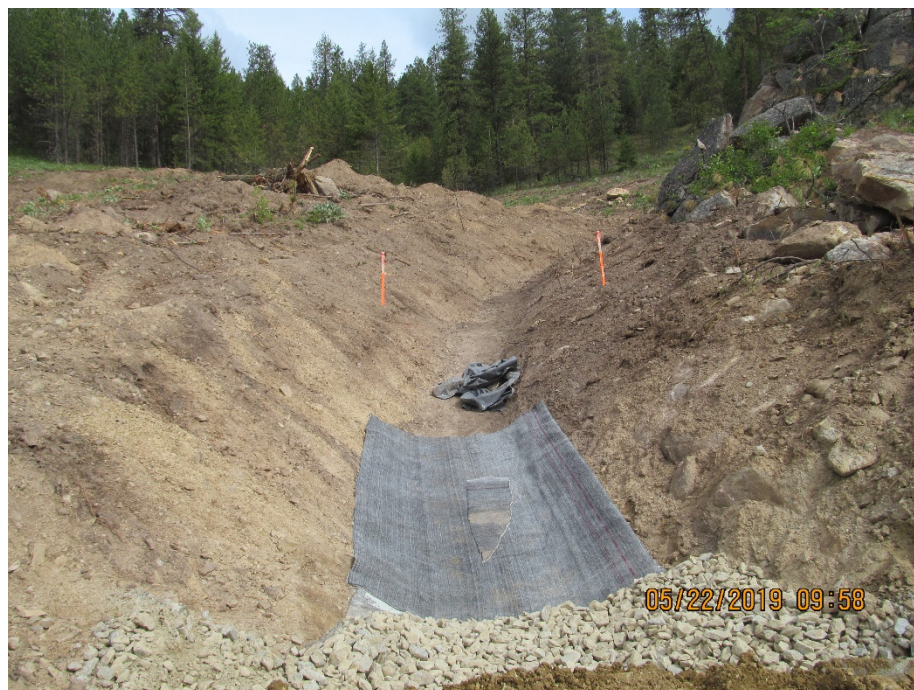
**Figure 4 Second Lateral Located Along the West Side of the WIC Main Collector
GCL Placement, Looking West. Orange stakes in background mark upper extent of subgrade that is
currently surveyed and approved for placement of GCL and Drain Gravel.**

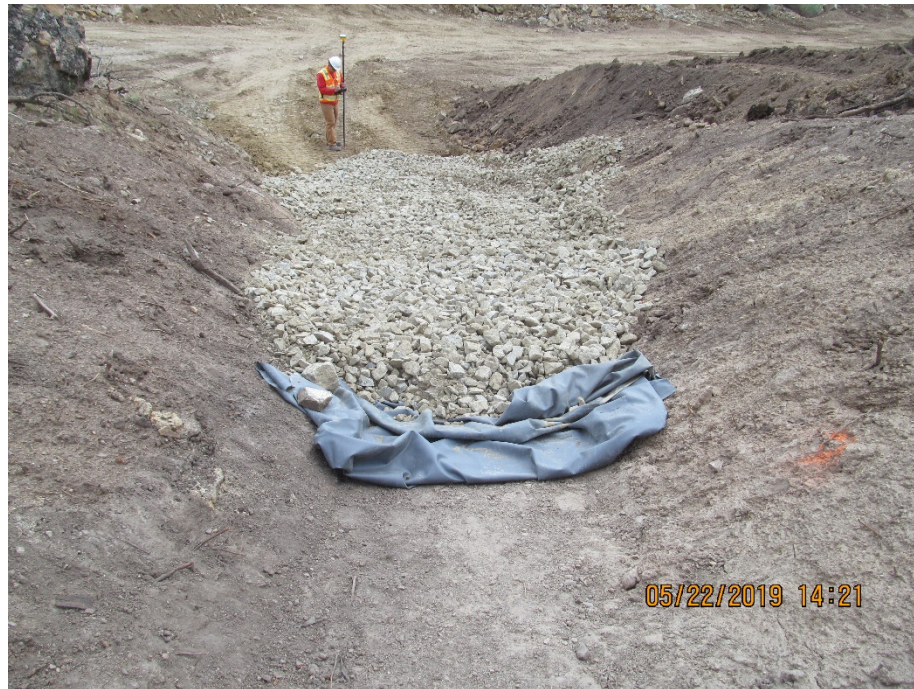
**Figure 5 Second Lateral Located Along the West Side of the WICS Main Collector
CQC Surveying Top of Drain Gravel Placement, Looking East**

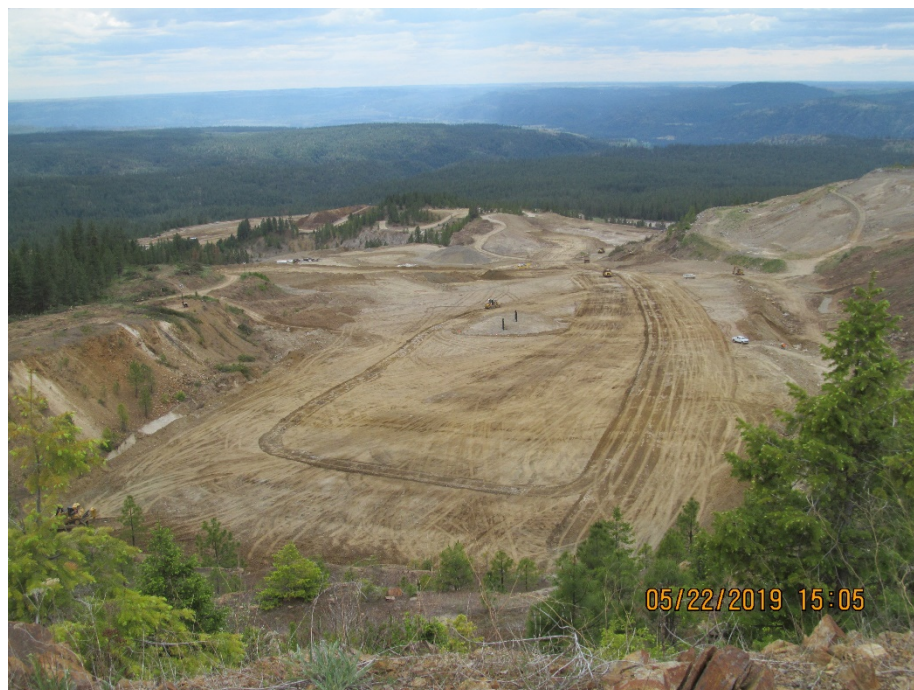
Figure 6 Pit 4 Overview, Looking South

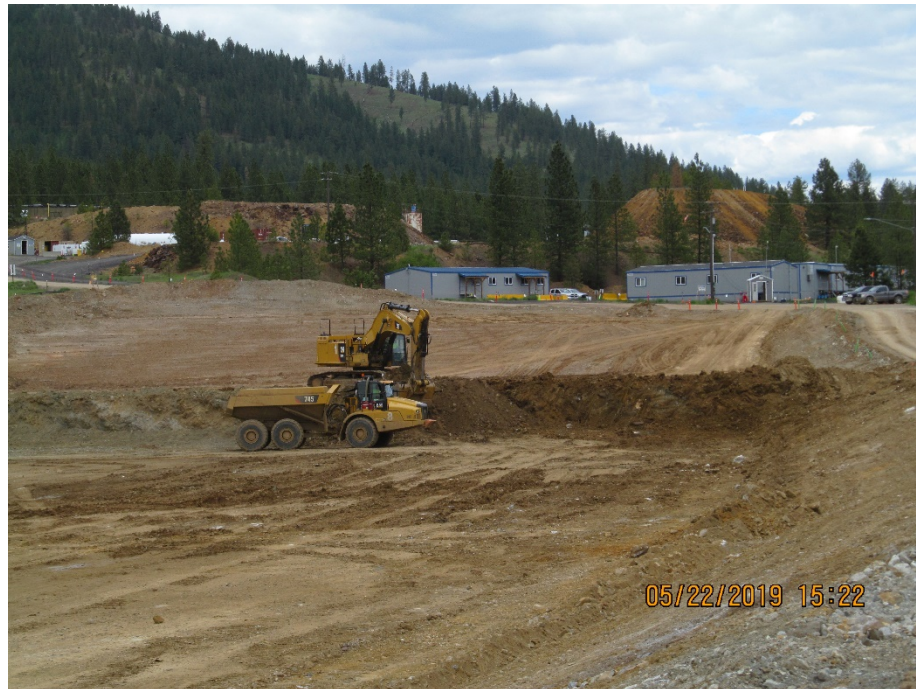
Figure 7 First Load-Out at the South Pond Cut, Looking East

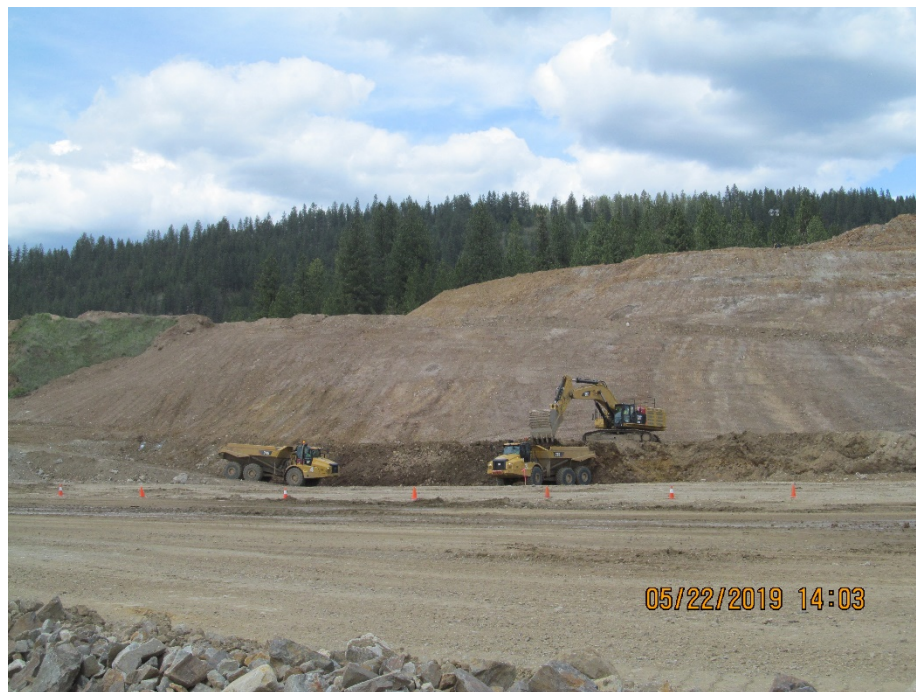
Figure 8 Second Load-Out at the South Pond Cut, Looking North

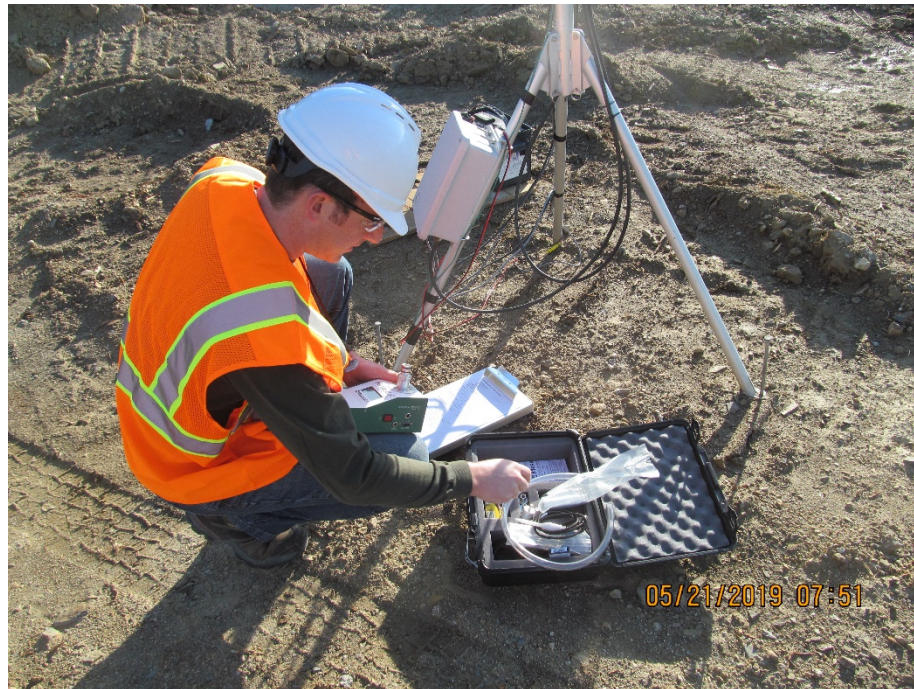
Figure 9 Bison Engineering - Monthly Dust Monitor Calibrations

Bison Engineering was on site 5/21/2019 to perform monthly calibration procedures for all on-site dust monitors (including spares).

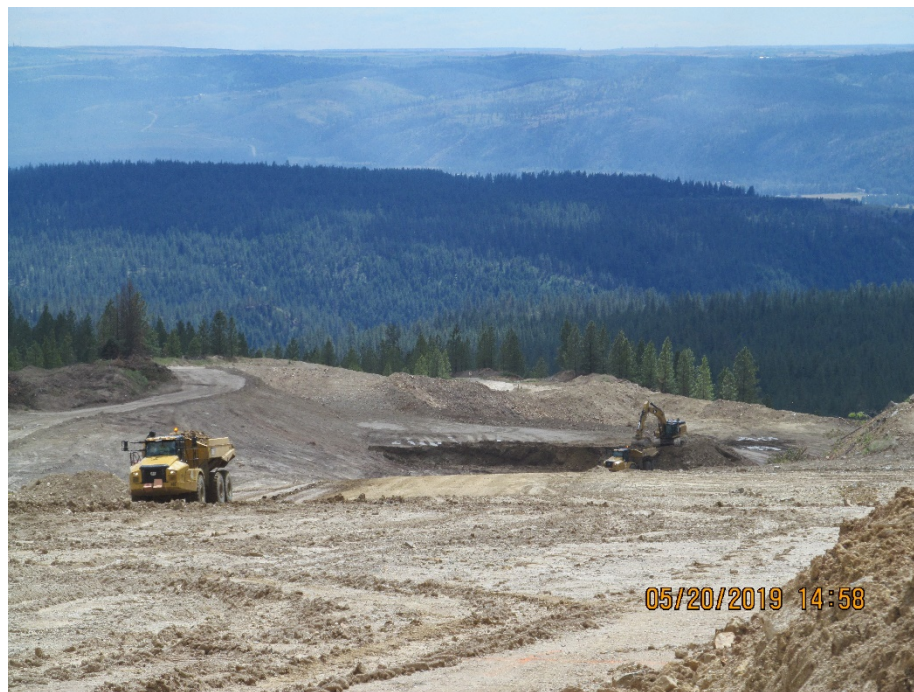
Figure 10 Load-Out at the North SWRP, Looking South
